Maryland Historical Trust

Maryland Inventory of Historic Properties Historic Bridge Inventory Maryland State Highway Administration
Maryland Historical Trust

Maryland Historical Trust
SHA Bridge No. 21049 Name: MD 844 over Beaver Creek
<u>Location:</u> Street/Road Name and Number: <u>MD 844 (Cavetown Church Road)</u>
City/Town: Smithsburg Vicinity X
County: Washington
Ownership: X State County Municipal Other
This bridge projects over:RoadRailway_X_WaterLand
Is the bridge located within a designated district: _yes X_no
_NR listed district_NR determined eligible district _locally designated_other Name of District
Bridge Type:
Timber BridgeBeam BridgeTruss-CoveredTrestleTimber-and-Concrete
_Stone Arch
_Metal Truss
_Movable Bridge _Swing _Bascule Single Leaf_Bascule Multiple Leaf _Vertical Lift_Retractile_Pontoon
Metal GirderRolled GirderRolled Girder Concrete EncasedPlate GirderPlate Girder Concrete Encased
_Metal Suspension
_Metal Arch
_Metal Cantilever
X Concrete X Concrete Arch Concrete Slab Concrete Beam Rigid Frame
_Other Type Name

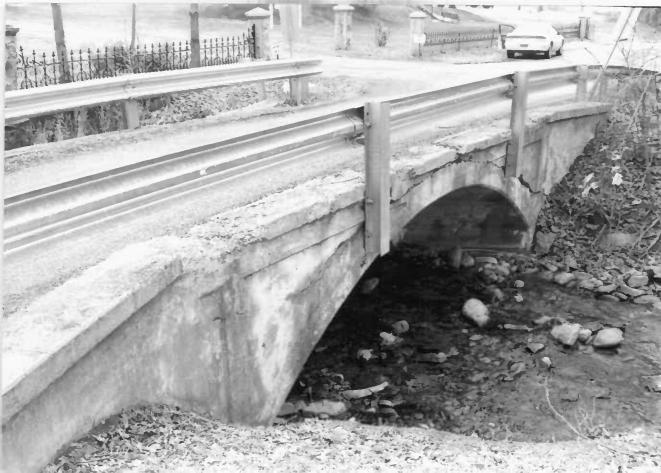
1 OF 3

WEST APPROACH
